Hurricane Kate

November 15-23, 1985

Department of Natural Resources
Division of Beaches and Shores
Post Storm Report No. 86-1
September, 1986
By Ralph Clark

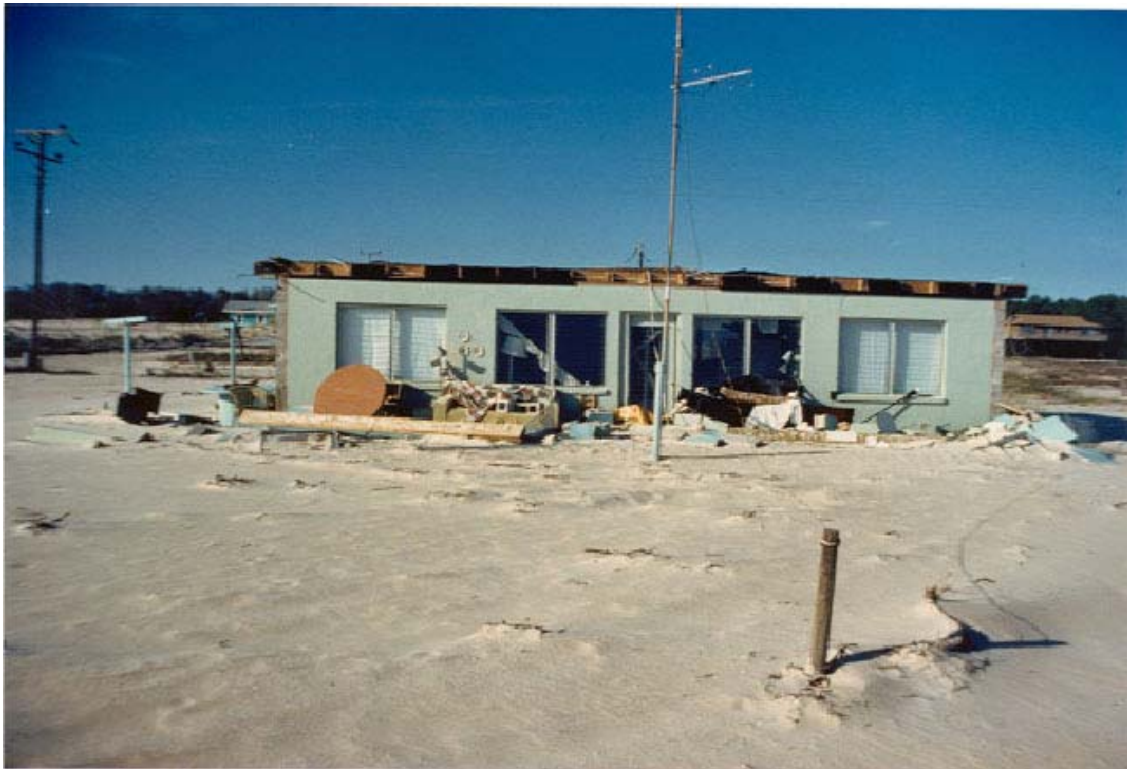
FIGURE 48. Structural roof damage due to wind and concrete block porch destroyed by waves.

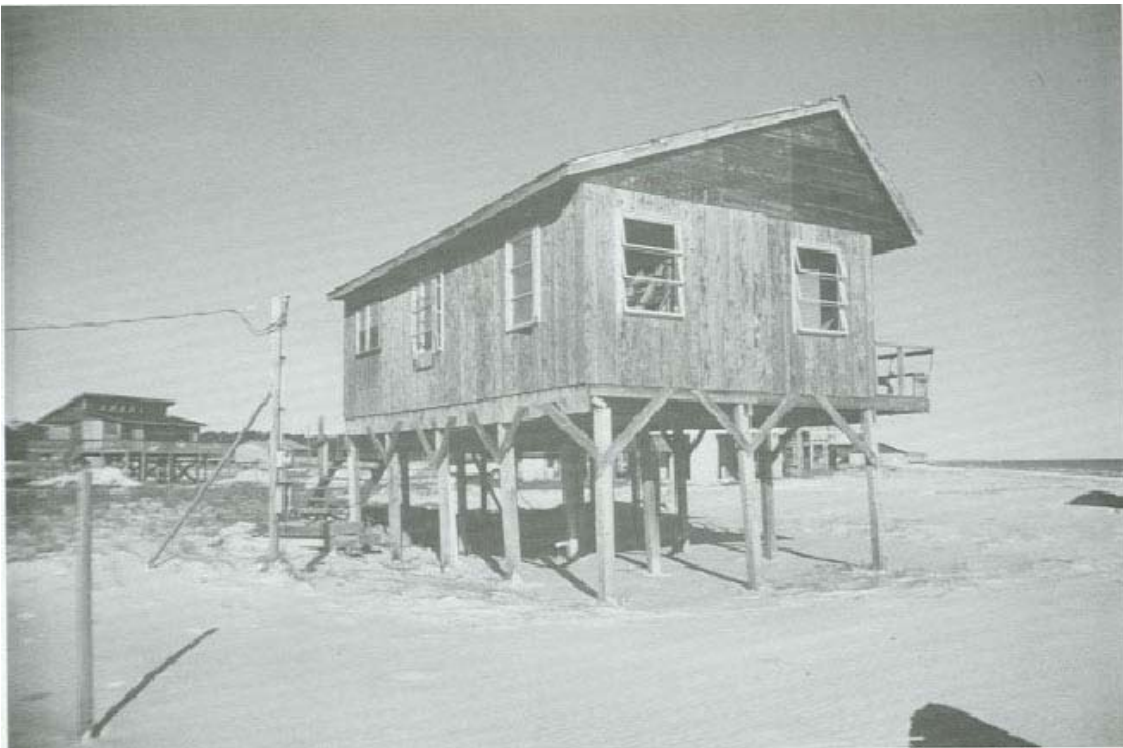
FIGURE 50. Pile-supported dwelling with inadequate pile to beam connections and insufficient pile penetration leans following wind loads and scour.

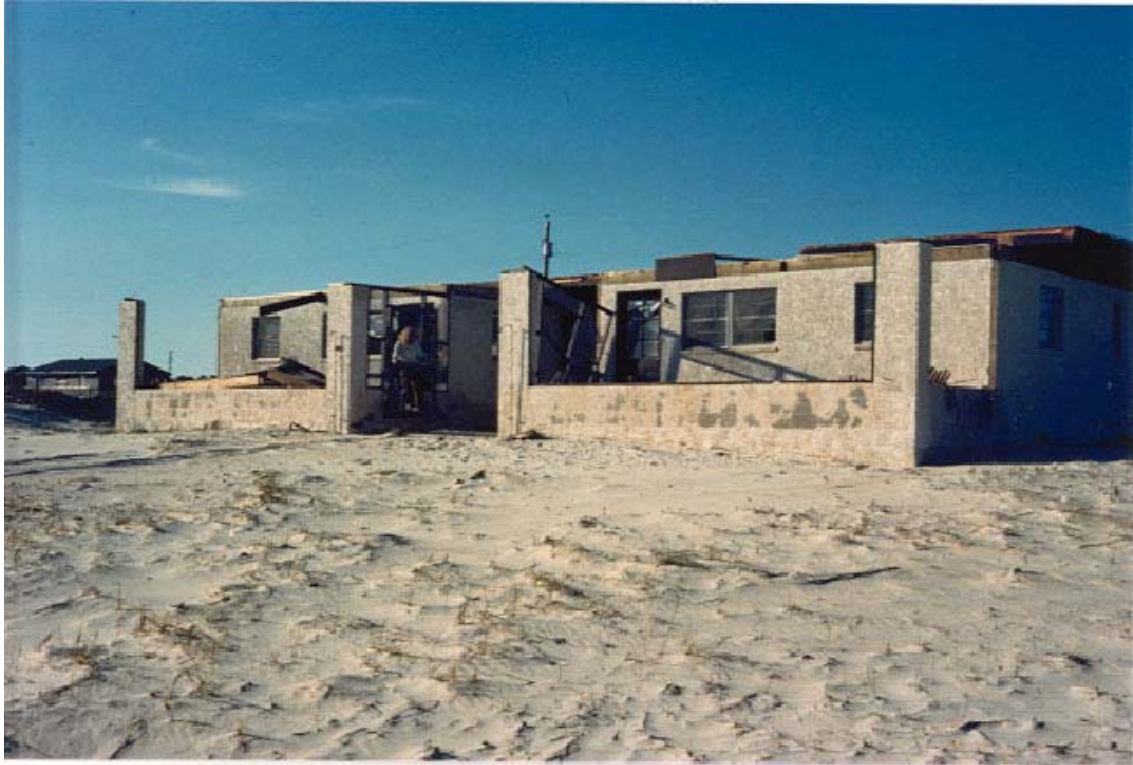
FIGURE 51. Duplex sustained major structural roof damage.

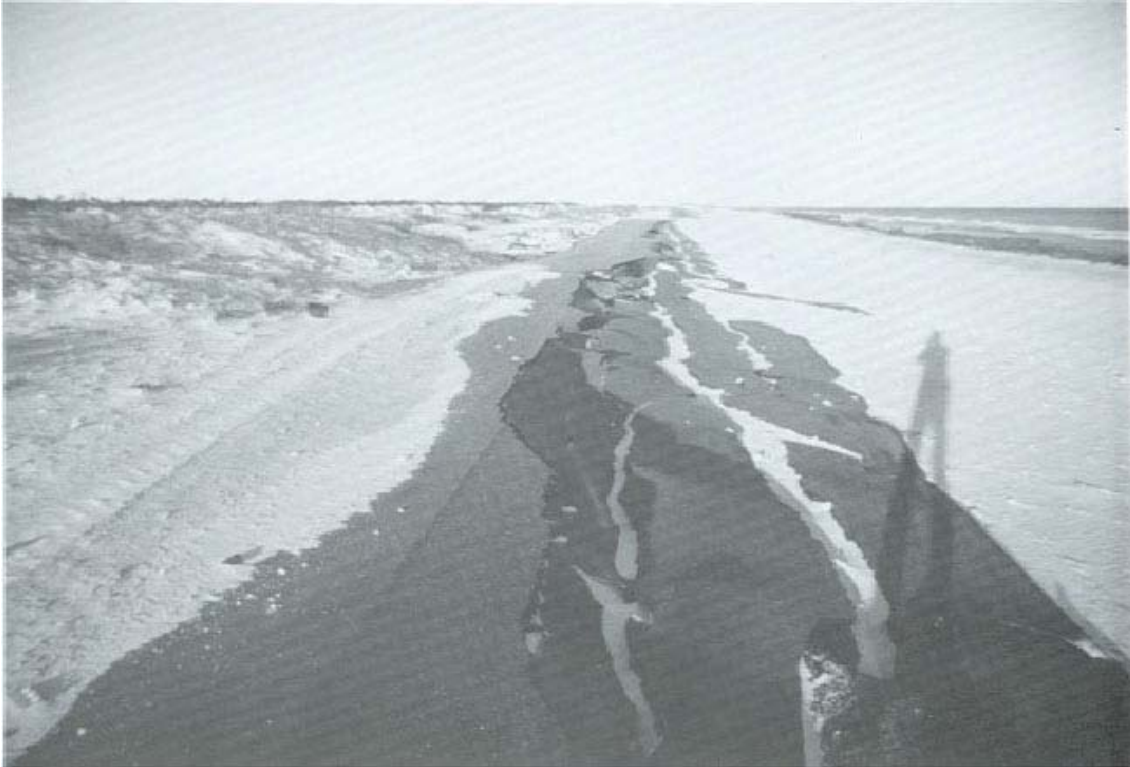
FIGURE 54. St. George Island State park road destroyed.
